Assessment of Dam Safety

Coal Combustion Surface Impoundments (Task 3)

PacifiCorp

Naughton Power Station

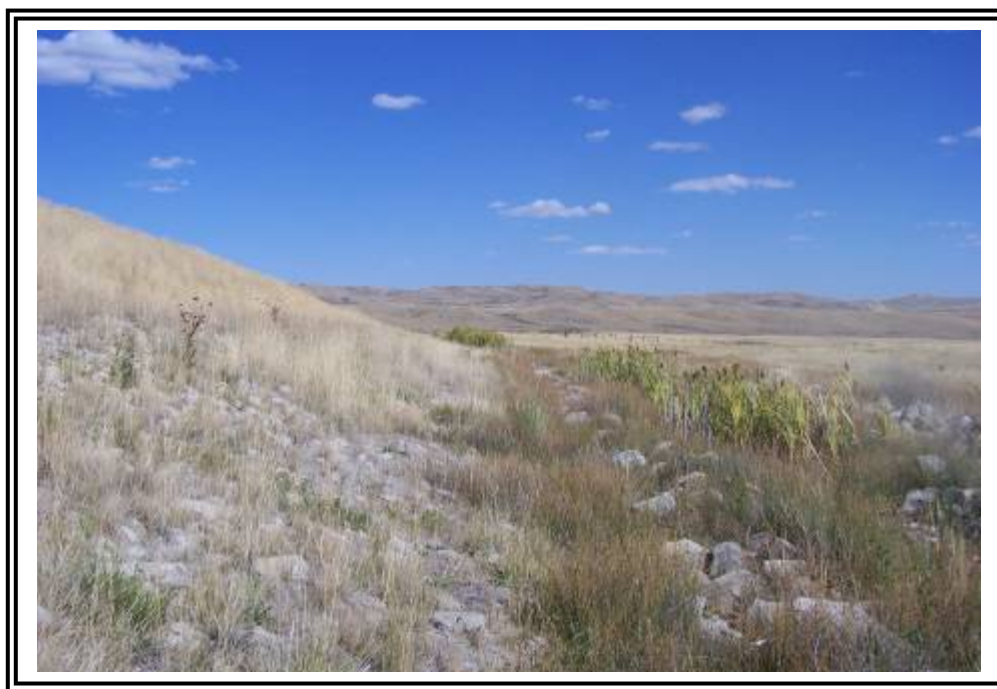
Downstream toe of Main Dike looking east from Main Dike outfall. Cat tails are in rip rap lined discharge channel.

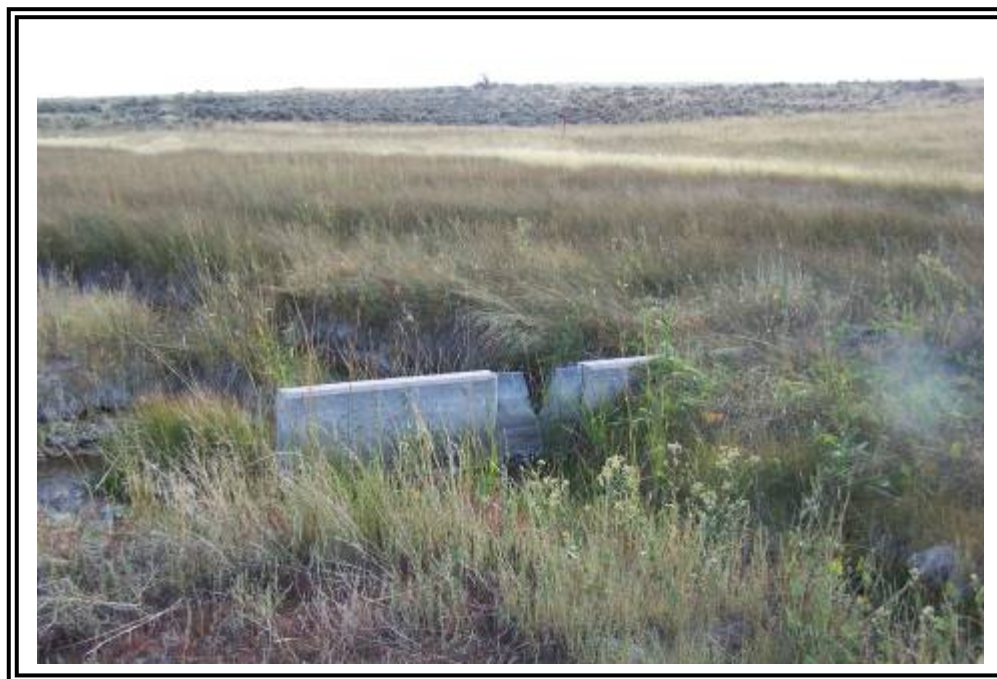
Former weir structure along discharge channel beyond the toe of the main dike. The weir is located on Bureau of Land Management property and is not used by the Naughton Plant in association with the North Ash Pond. Discharge channel has bypassed the weir structure on the east side.

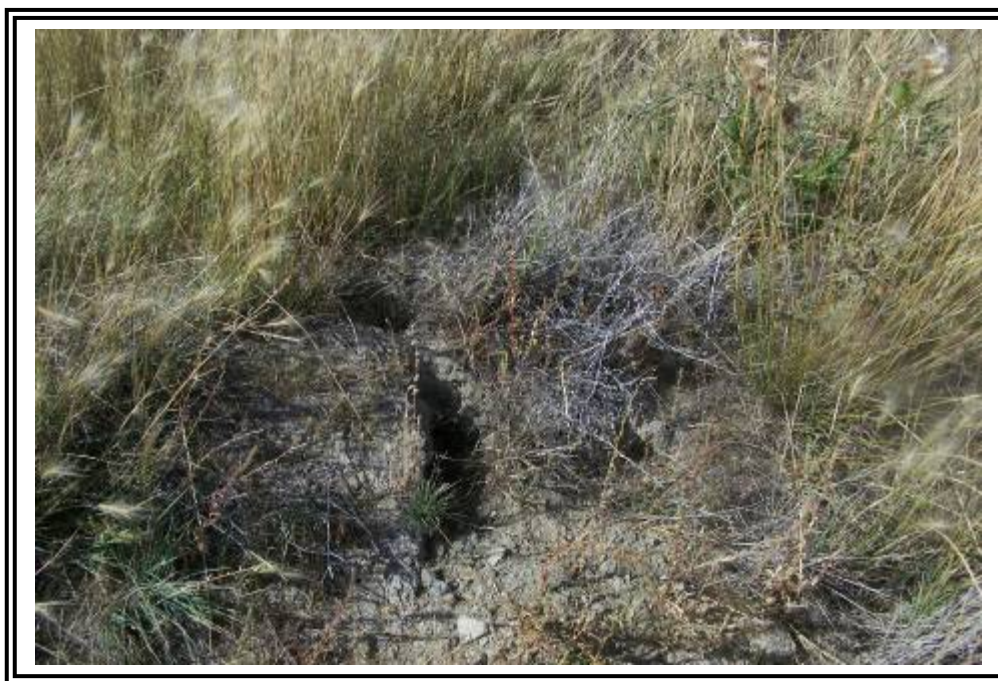
Occasional animal burrows on downstream slope of Main Dam.

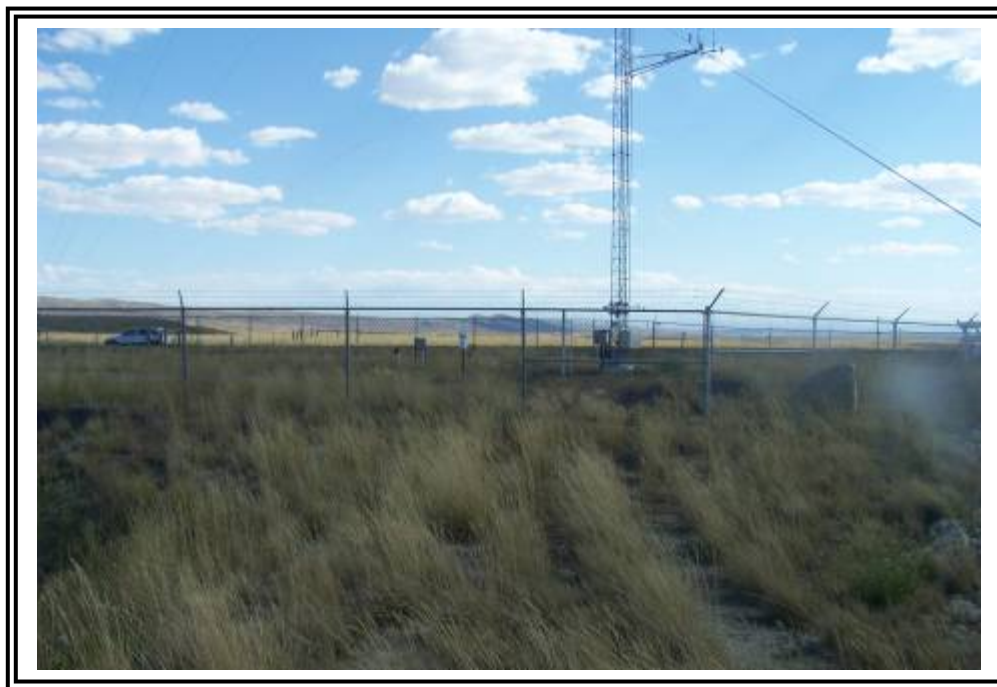
South abutment of East Saddle Dike. Note guy wire at right of photo is anchored in the dike.

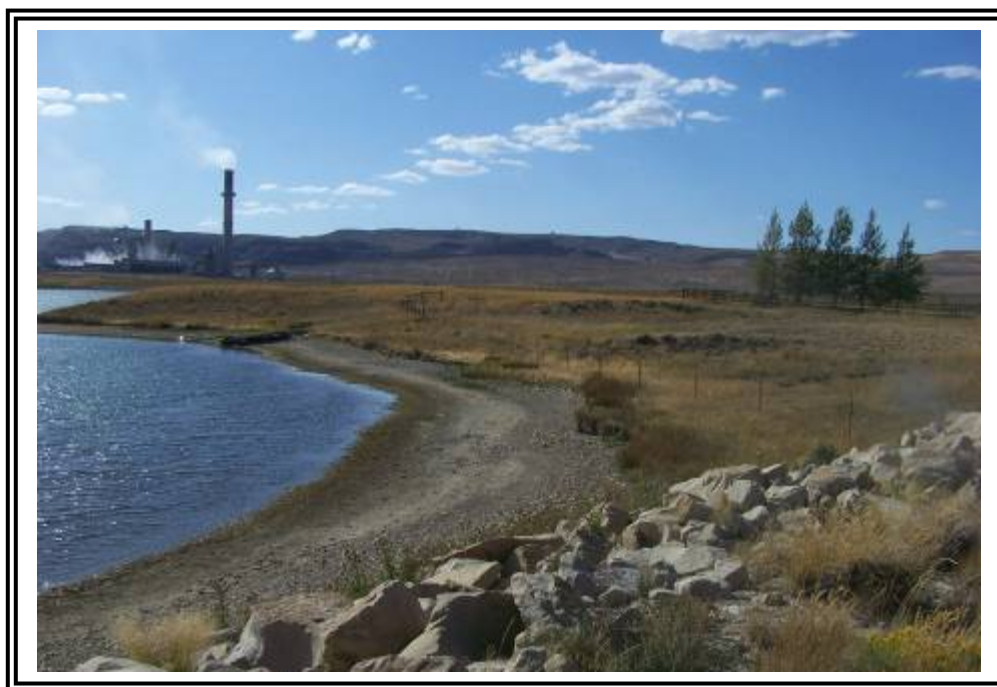
Clearwater Pond is not submerging the north end of the East Saddle Dike at normal pool.

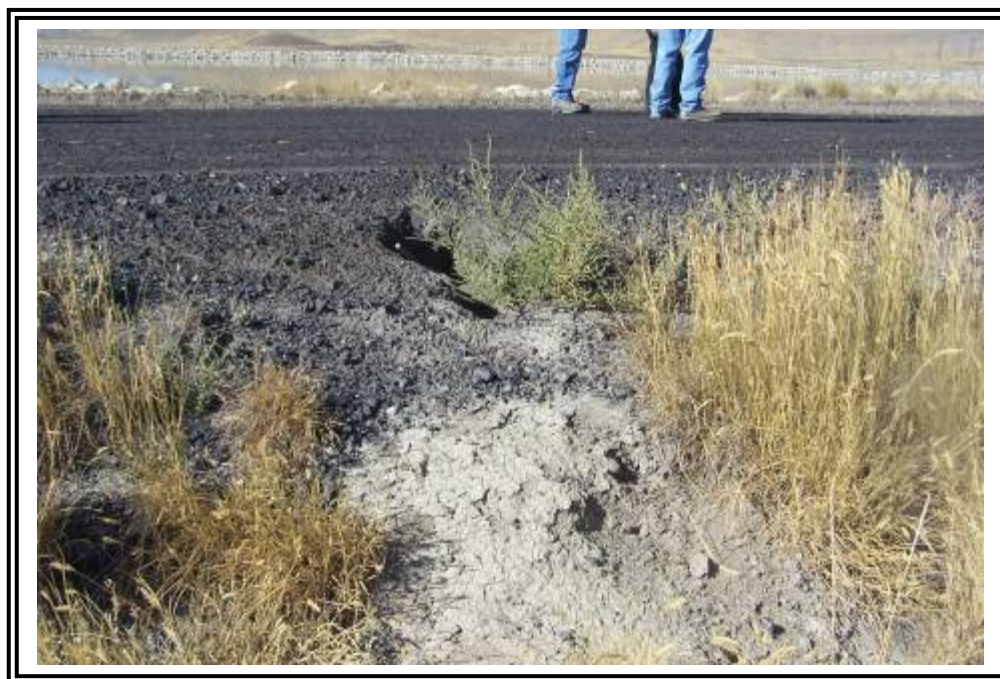
Animal burrow on east dike.

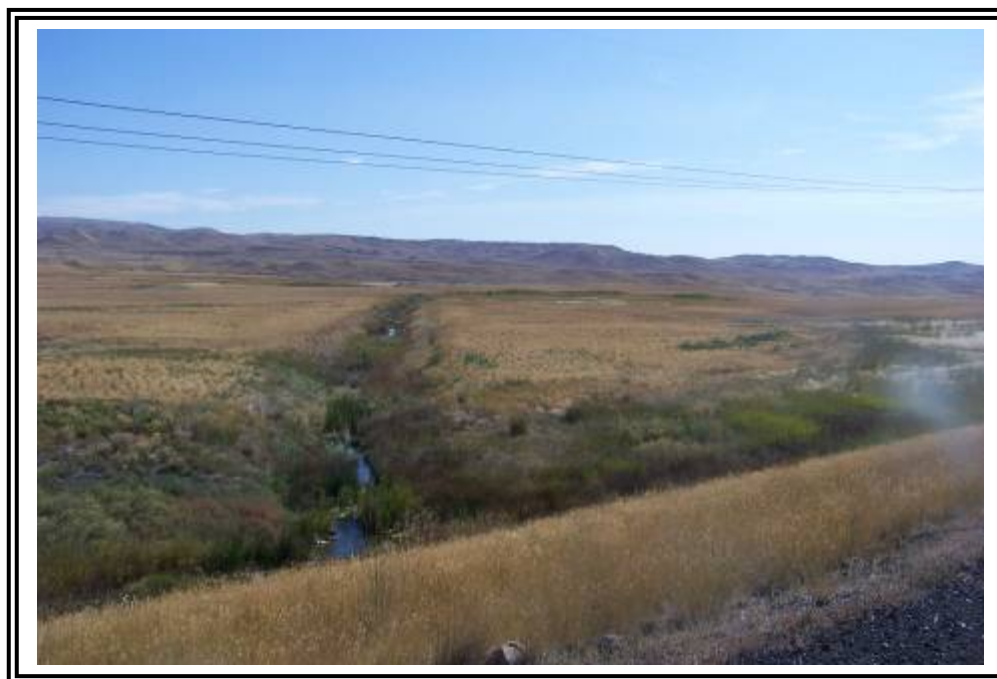
Discharge channel diverts away from northeast dike. Possible seepage to southeast (right in photo) of diversion point.

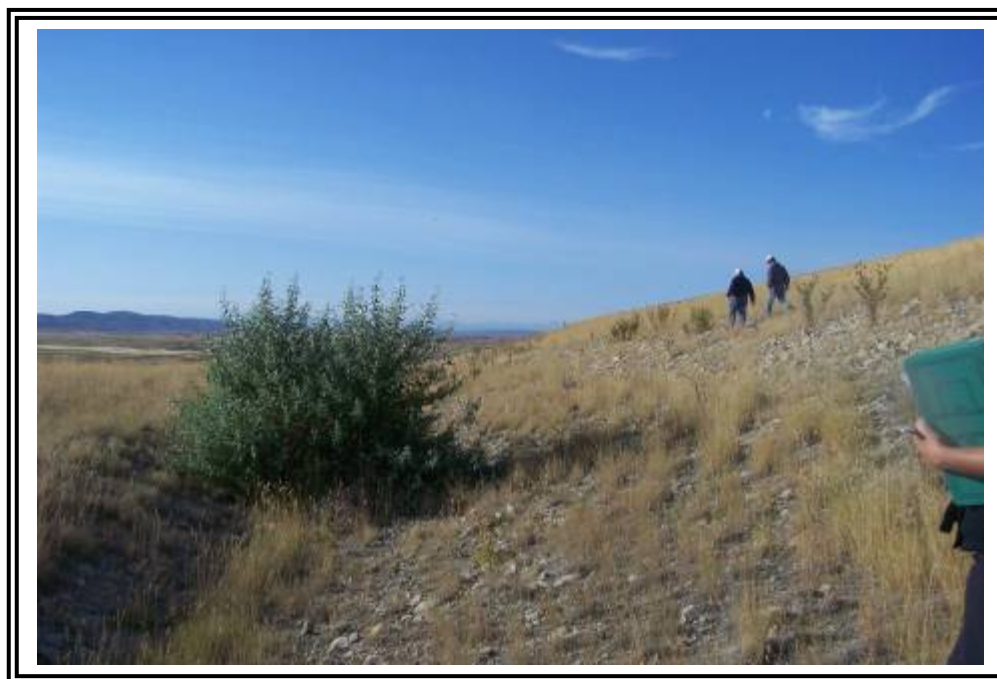
Sage bush at toe of East Dike. Gravel along lower portion of slope associated with toe drain (looking south).

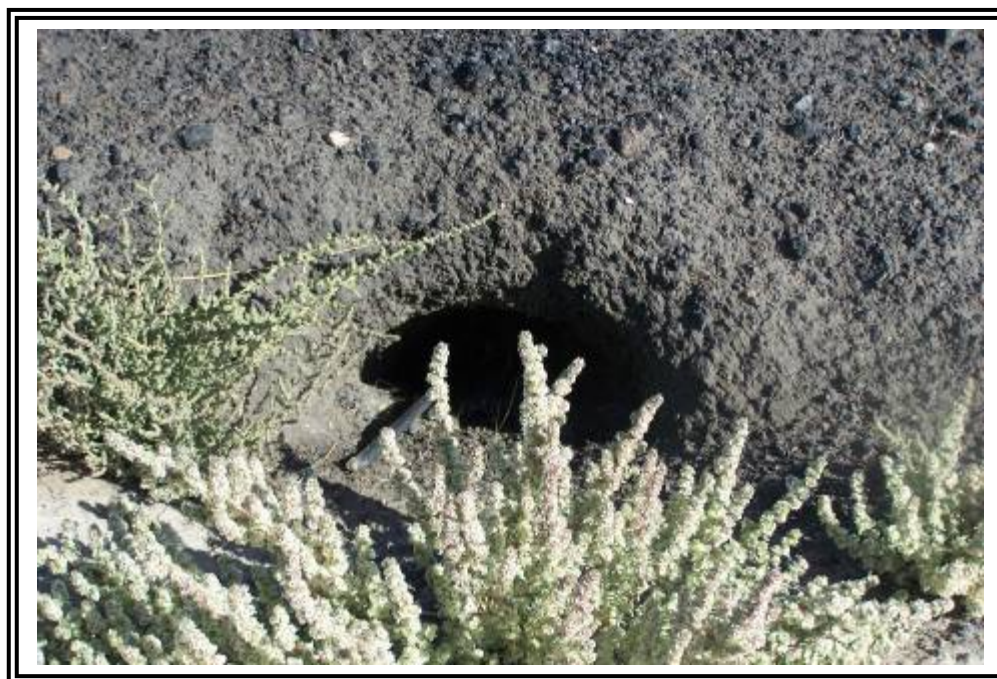
Close up of animal burrow on East Dike, 2 foot rebar sticking out about 6-8 inches.

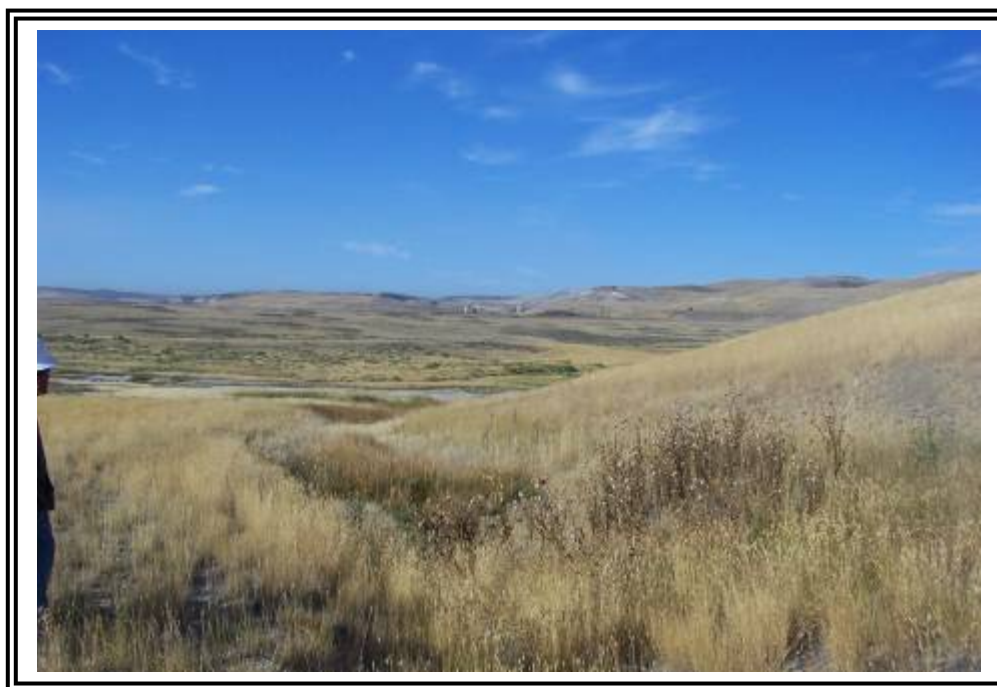
Seepage area at south end of East Dike.

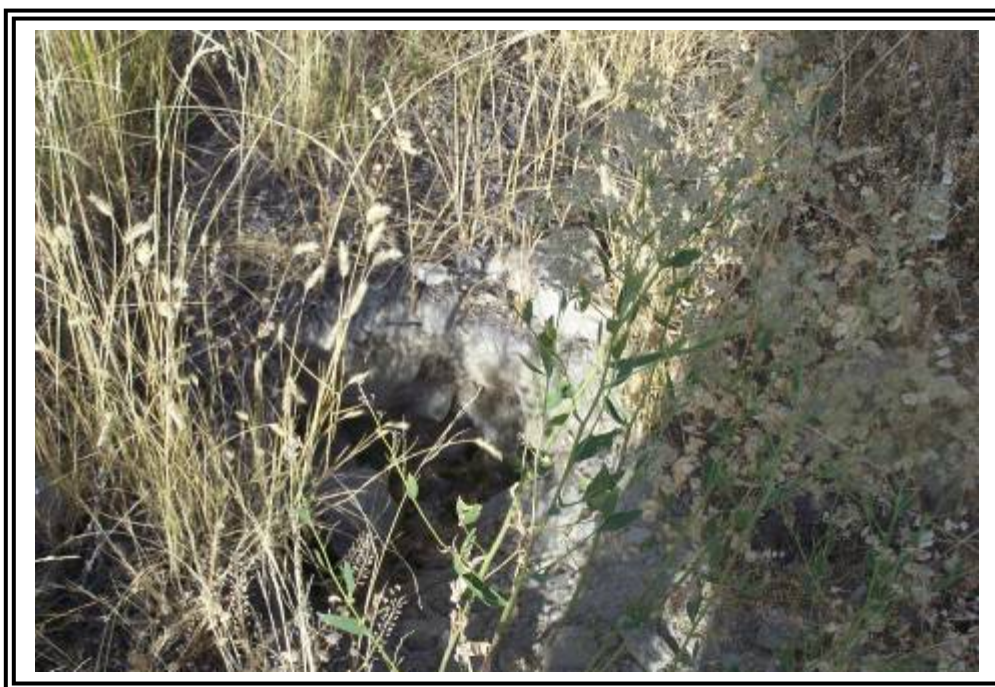
Close up of animal burrow.

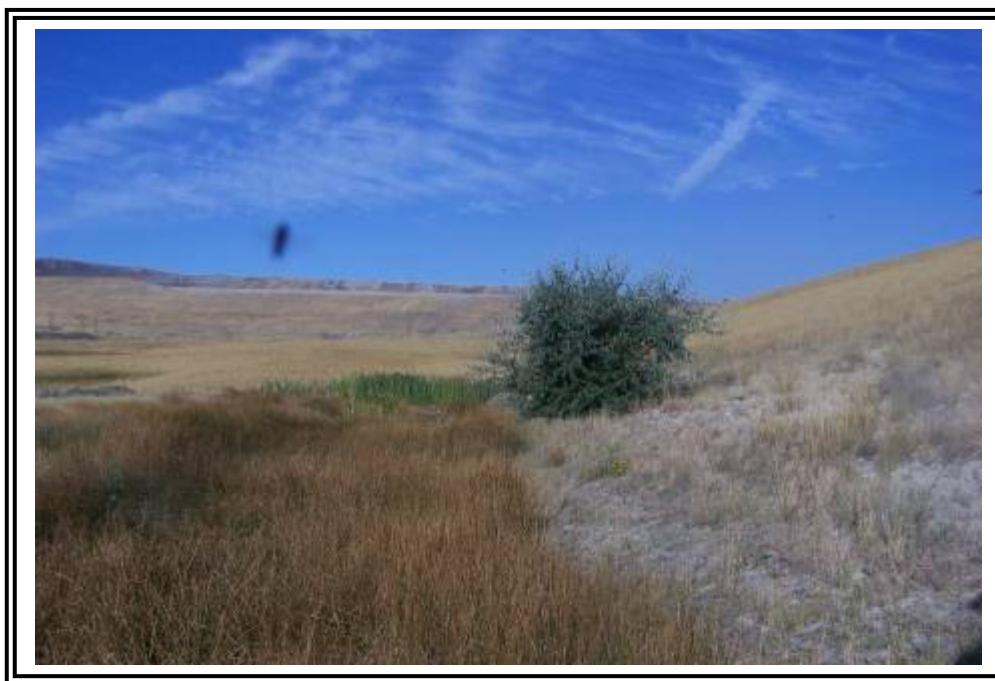
Seepage at South Dike toe, sage bush, looking west.

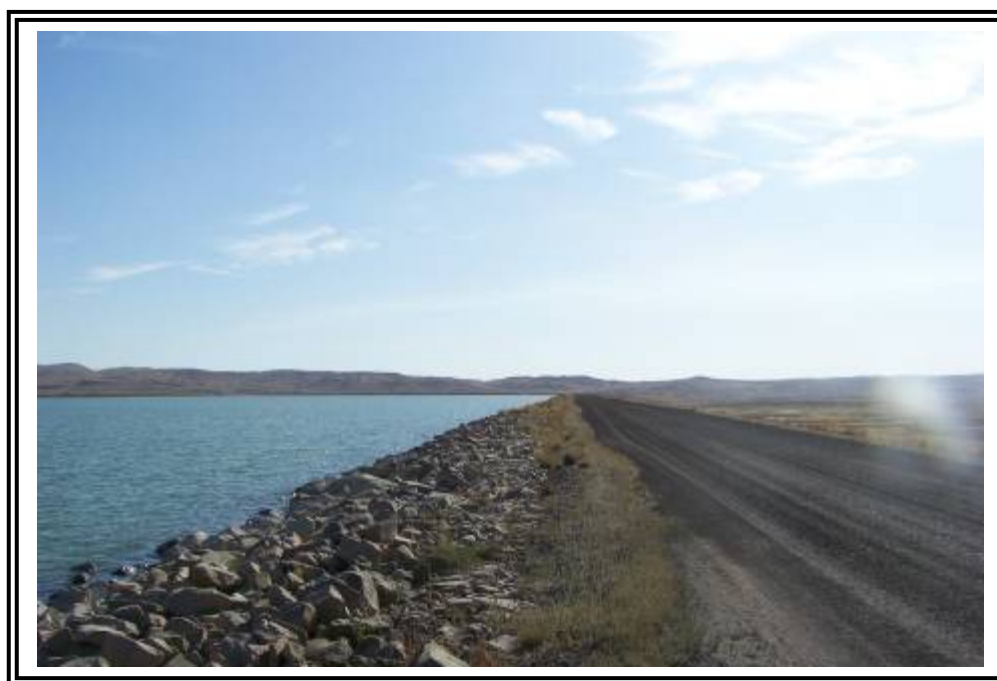
122

Upstream slope of South Dike, looking east.

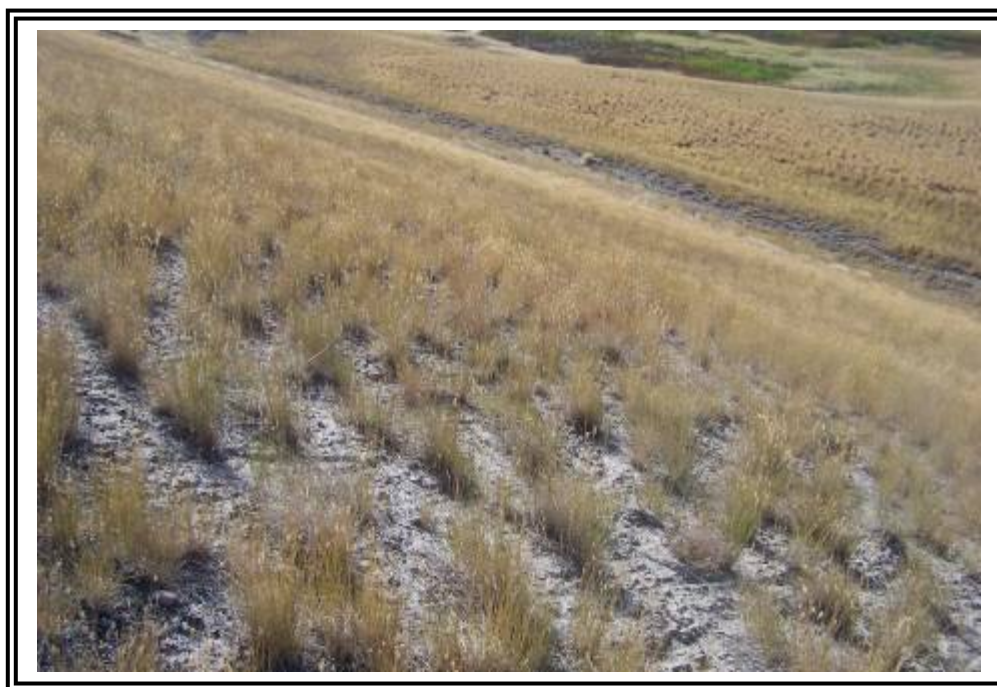
123

Typical vegetation at upper portion of South Dike downstream face.

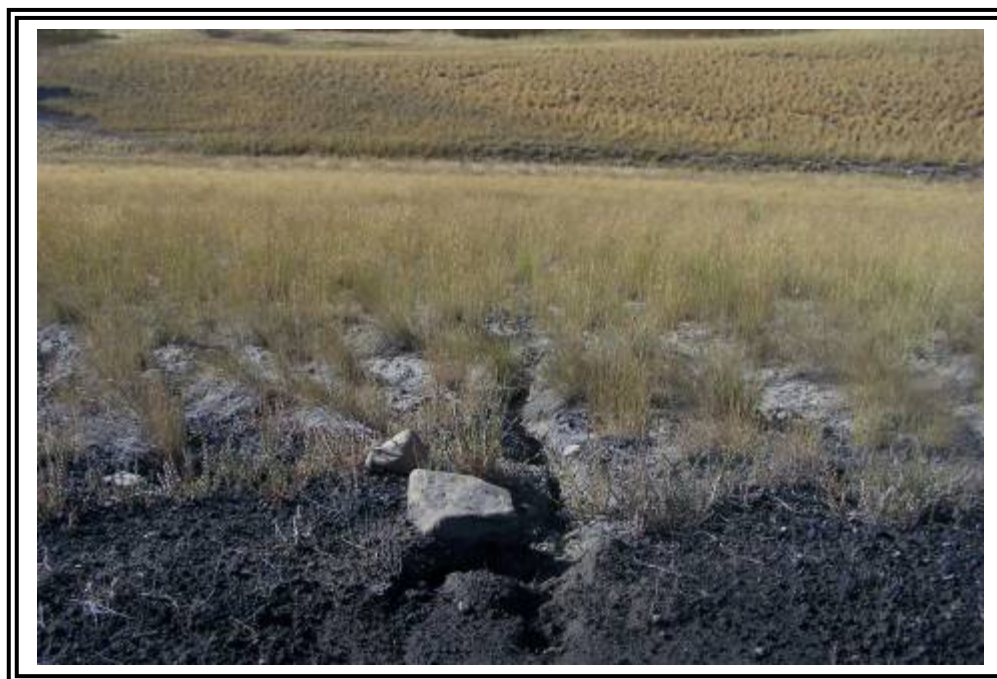
124

Occasional erosion rills along crest/downstream slope contact on South Dike.

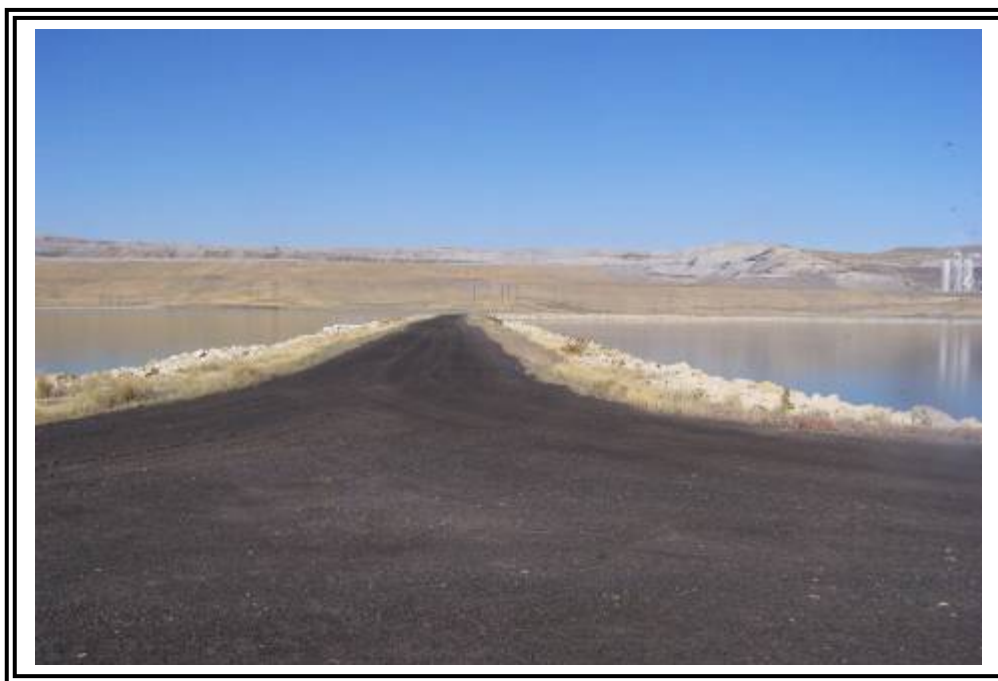
126

Crest of Intermediate Dike, looking west. Upstream and downstream faces covered with large rip rap.
Primary pond to the left, clear water pond to the right.

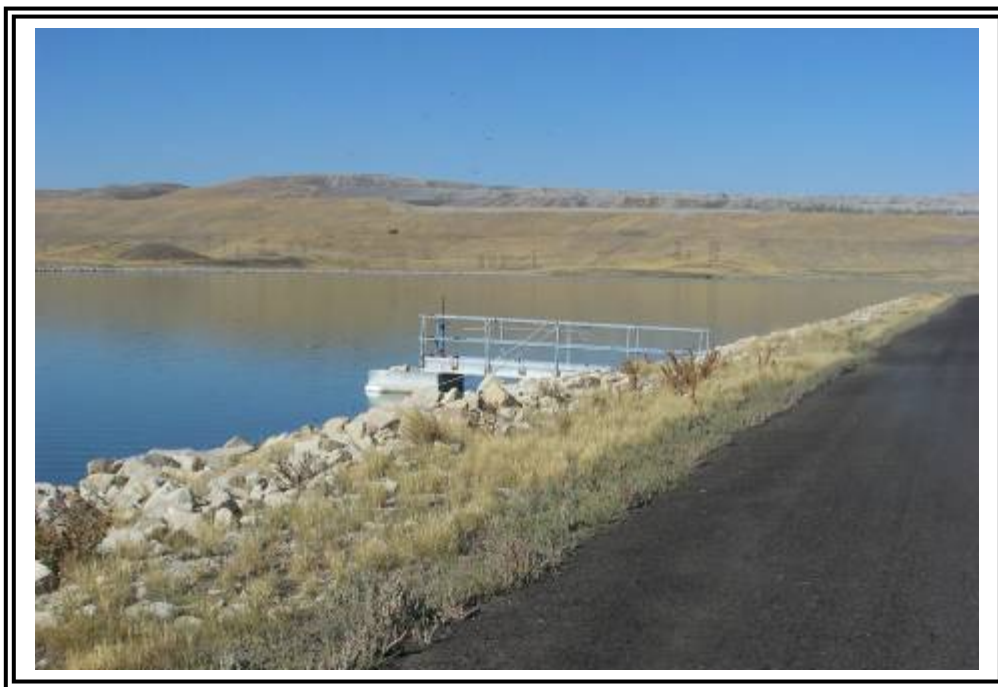
127

Decant structure in primary pond.

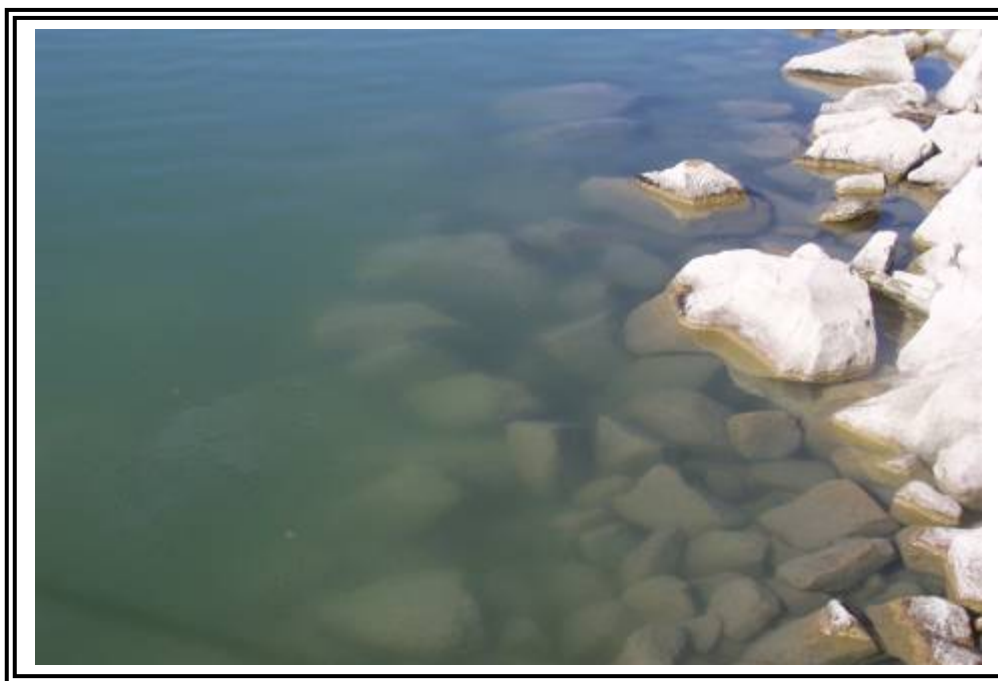
128

Typical rip rap on submerged slope extends below the water level.

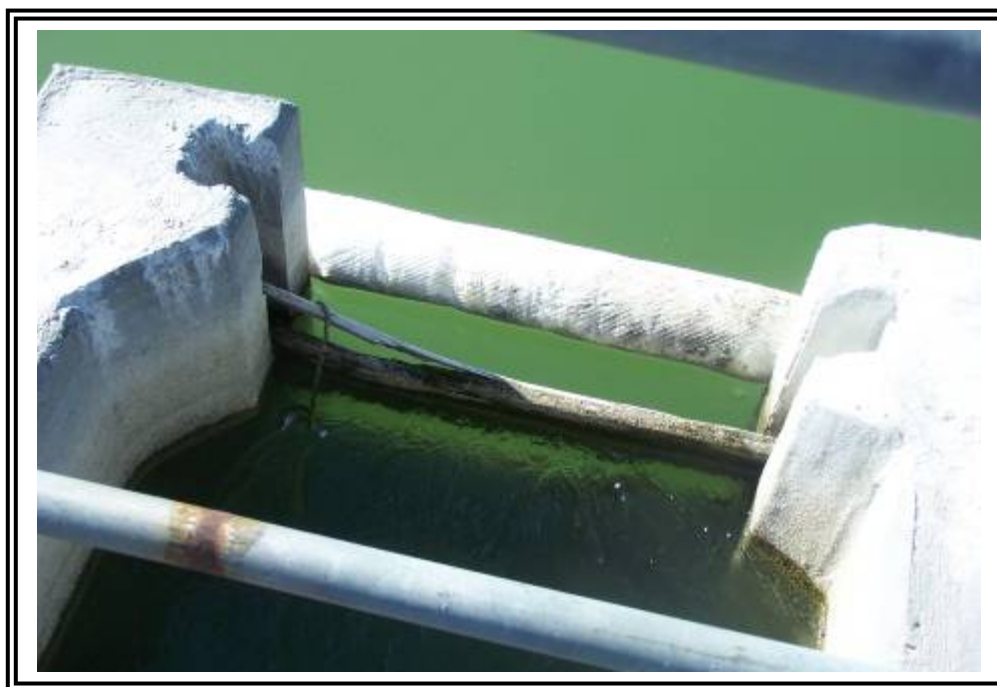
129

Intake.

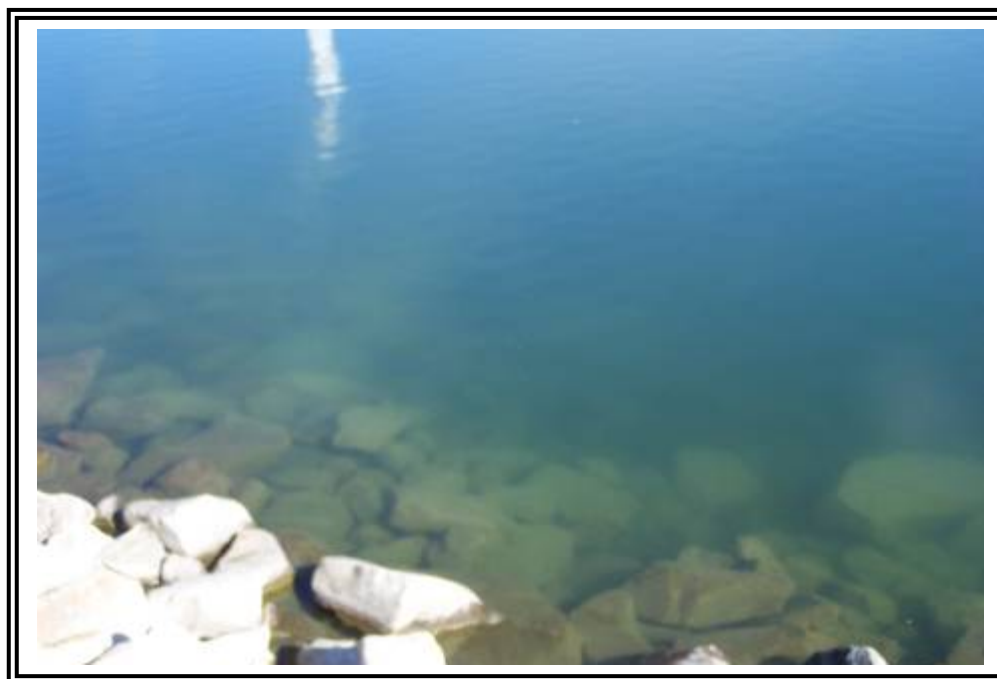
130

Area of discharge into Clearwater Pond submerged and surrounded by rip rap.

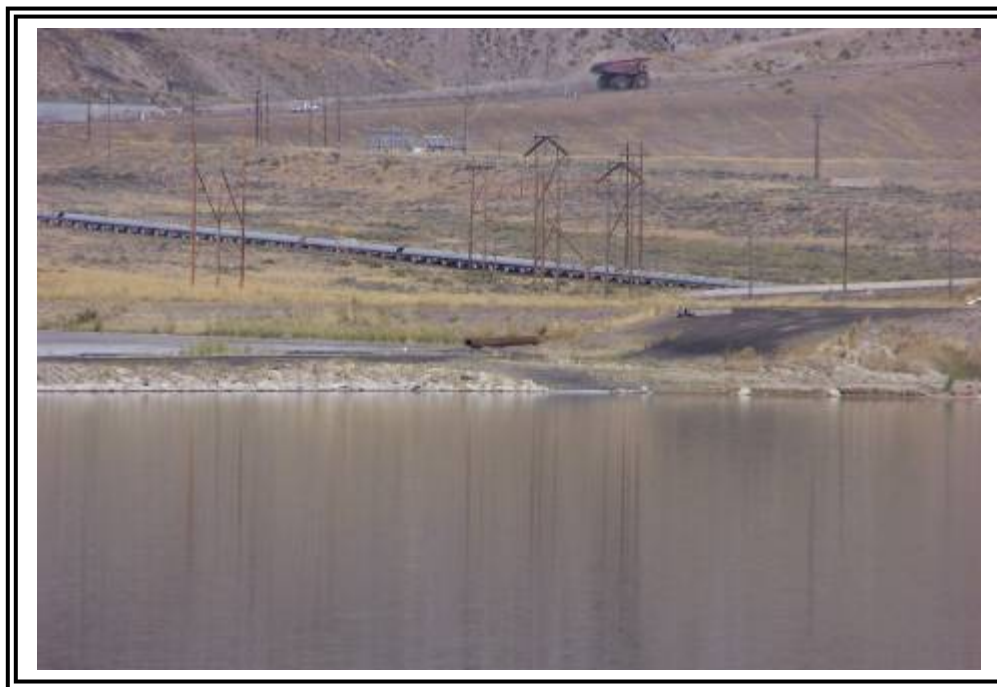
131

Sluice discharge into north side of South Ash Pond.
